**A CASE STUDY: DAMAGE TO THE METROPOLITAN
OAKLAND INTERNATIONAL AIRPORT CAUSED BY
THE LOMA PRIETA EARTHQUAKE**

Barney A. Vallergera

William P. Grogan

Final Report

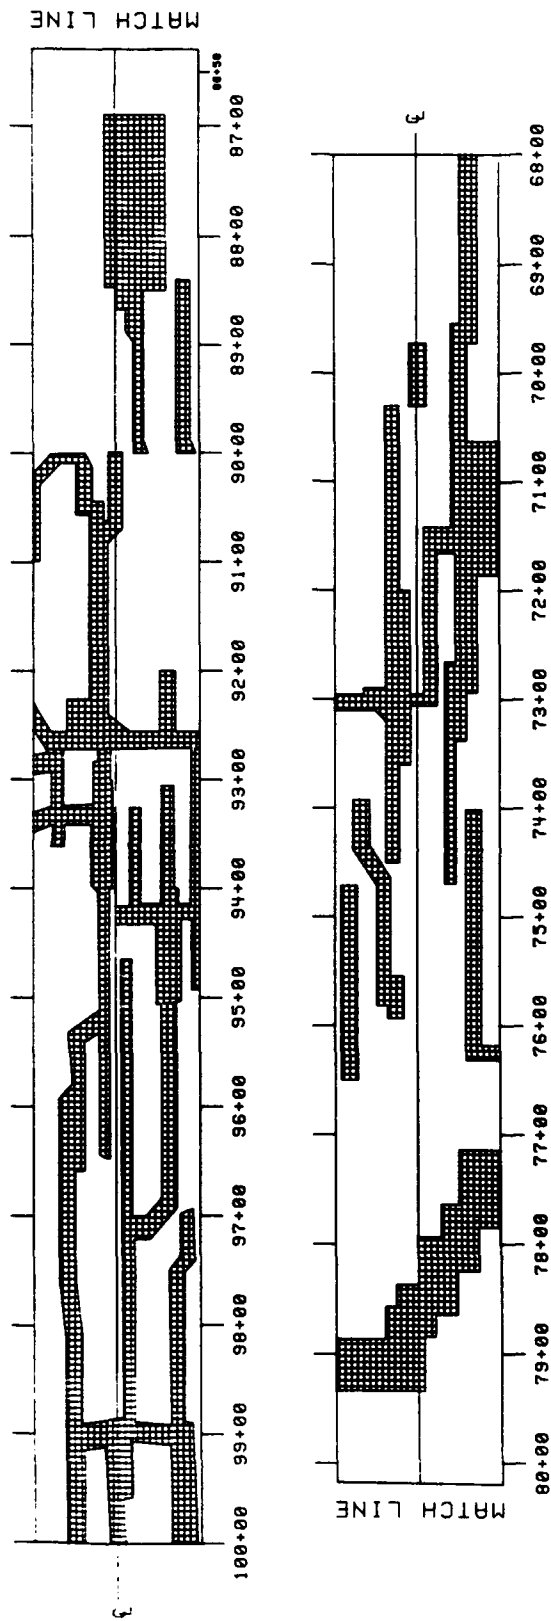
the MOIA airfield runway pavement that had to be repaired due to cracks as a result of the Loma Prieta Earthquake. This report presents and discusses the conditions that lead to the failure of the 3,000 ft of runway, describes the damage which occurred, recites what was done to repair the runway, and gives an overview of possible solutions to reduce the susceptibility of the airfield to damage in the event of a future earthquake.

Figure 2. Plan view of areas requiring repair after earthquake

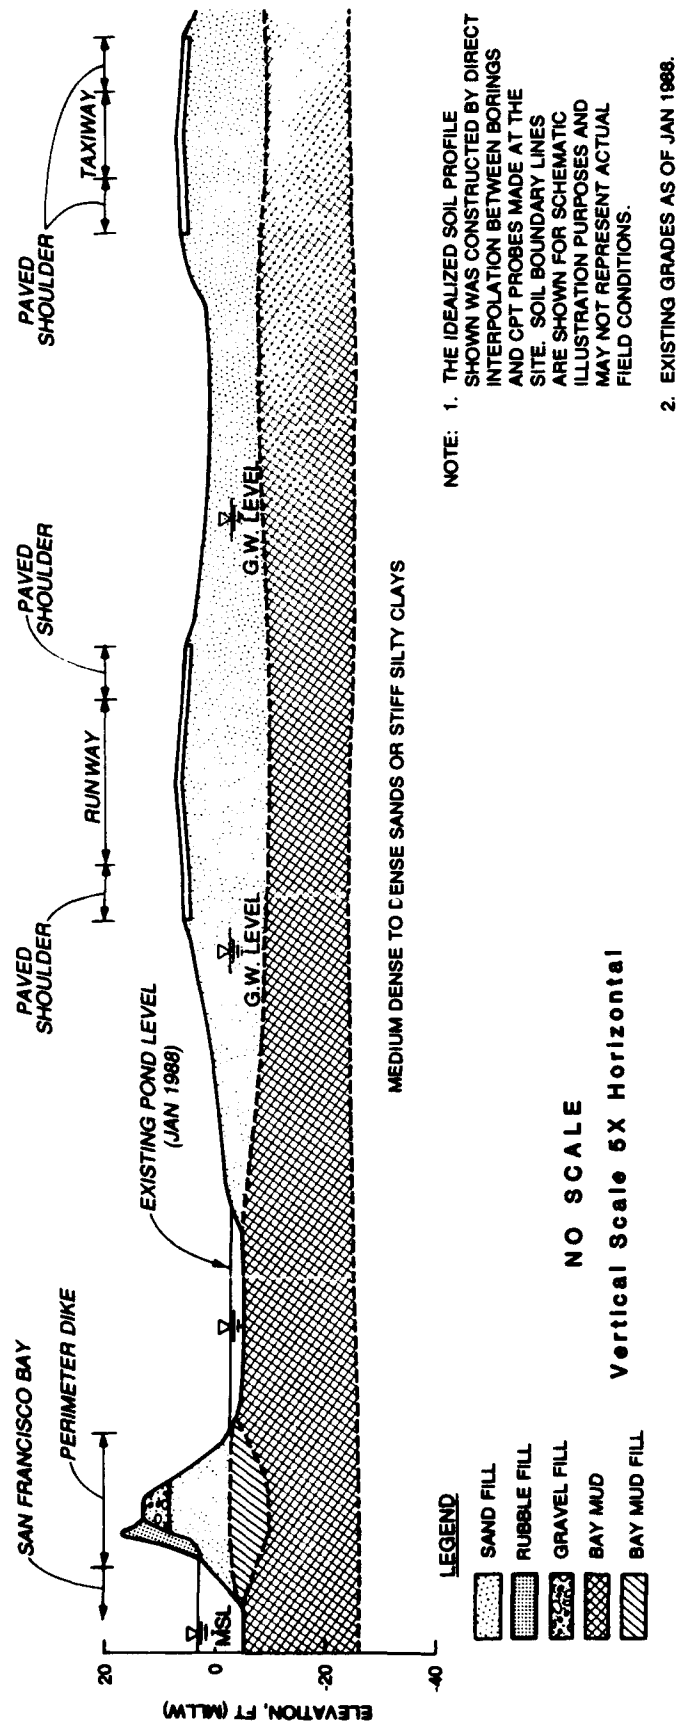
OAKLAND INTERNATIONAL AIRPORT RUNWAY 11-29
CROSS-SECTION STATION 88+00

8. A cross section of the airfield through the dike, the runway, and the taxiway is shown in Figure 3. Figure 3 shows some critical items that make this site susceptible to liquefaction damage. The relatively loose hydraulic sandfill with a high water table over bay mud on medium to dense sands or stiff silty clay makes the MOIA site vulnerable to liquefaction. The layers underlying the fill intensified the ground shaking helping to cause the sandfill to liquefy. The mean high sea level at 5.8 ft maintains a high water table in the sandfill. Typically the water table is approximately 7 to 10 ft

32. A final contributing factor causing the last 3,000 ft of runway to sustain damage was the geology of the area. As shown in Figure 3, the last part of the runway was constructed over an area of mud deeper than that over which the rest of the airfield was constructed. This difference in geology led to a different response to the earthquake loading.

Figure 3. Cross section through dike and runway

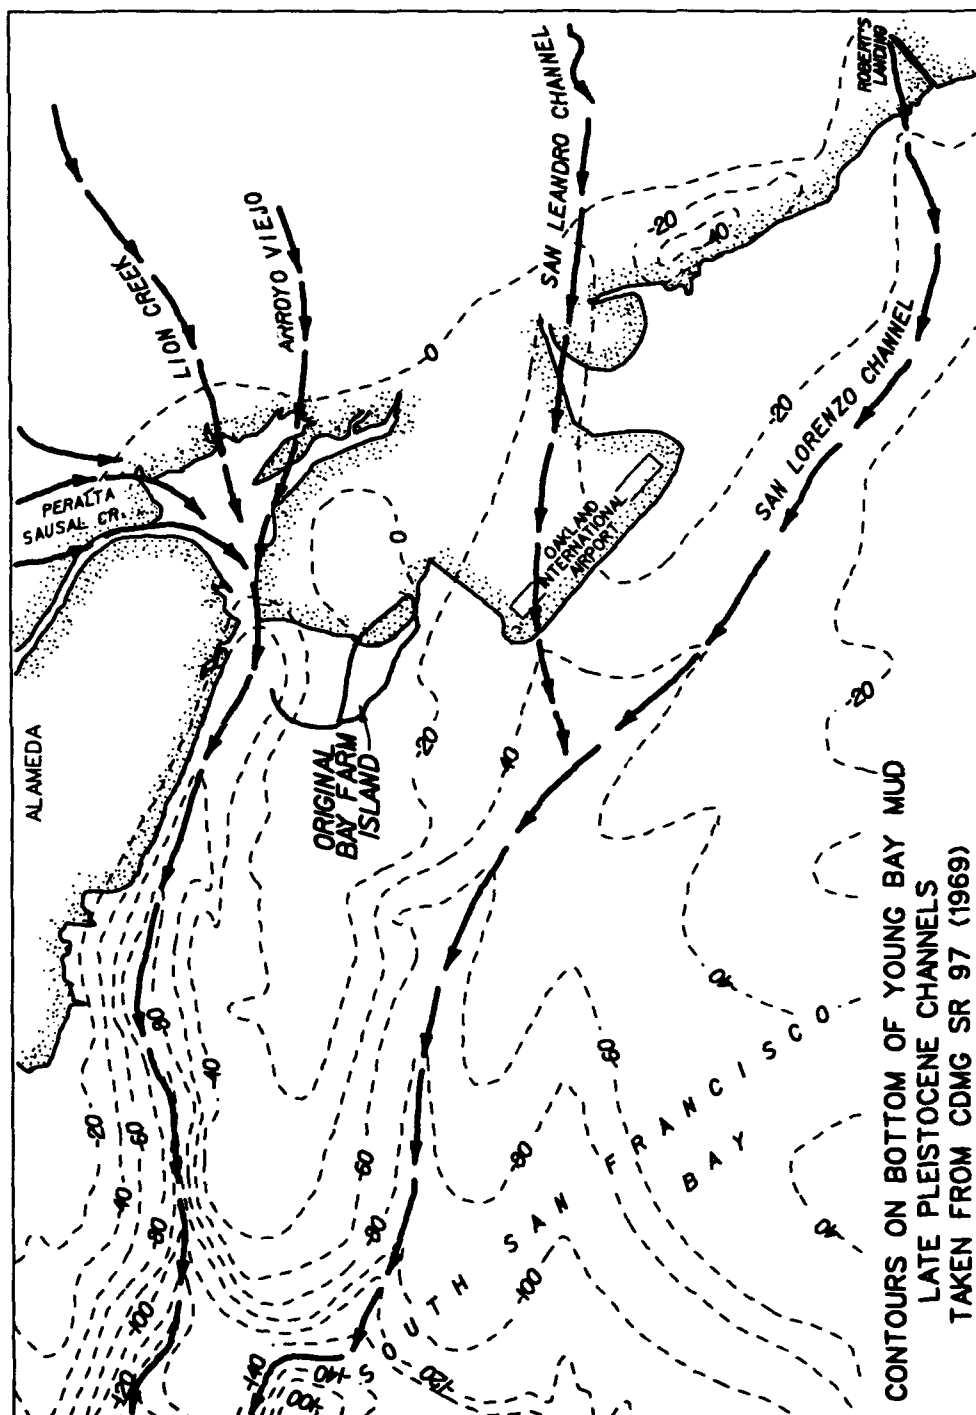
12. An interesting geologic feature may have added to the susceptibility of the west end of the runway to liquefaction. A map entitled "Contours on Bottom of Young Bay Mud", found in the California Division of Mines and Geology (CDMG) Special Report 97, shows the Late-Pleistocene topography before the rising sea levels and the deposition of the Young Bay Muds. Figure 4 shows the topography around the airport from CDMG Special Report 97 with some interpolations. The contours in Figure 4 show the San Leandro Creek channel crossing the western end of the MOIA Runway 11-29. The deeper Young Bay Muds (Rogers 1990) in this area would lead to lengthened site periods and amplified strong motion components. The strong motions resulting from this deeper mud would provide for more intense ground shaking in the liquefaction susceptible soils underlying the western part of the runway than under the eastern part. Liquefiable soils underlie the entire runway, but the increased ground motion in the area of the deeper muds may have made the west end of the runway more vulnerable to liquefaction damage than the rest of the runway.

Figure 4. Topography of Young Bay Muds

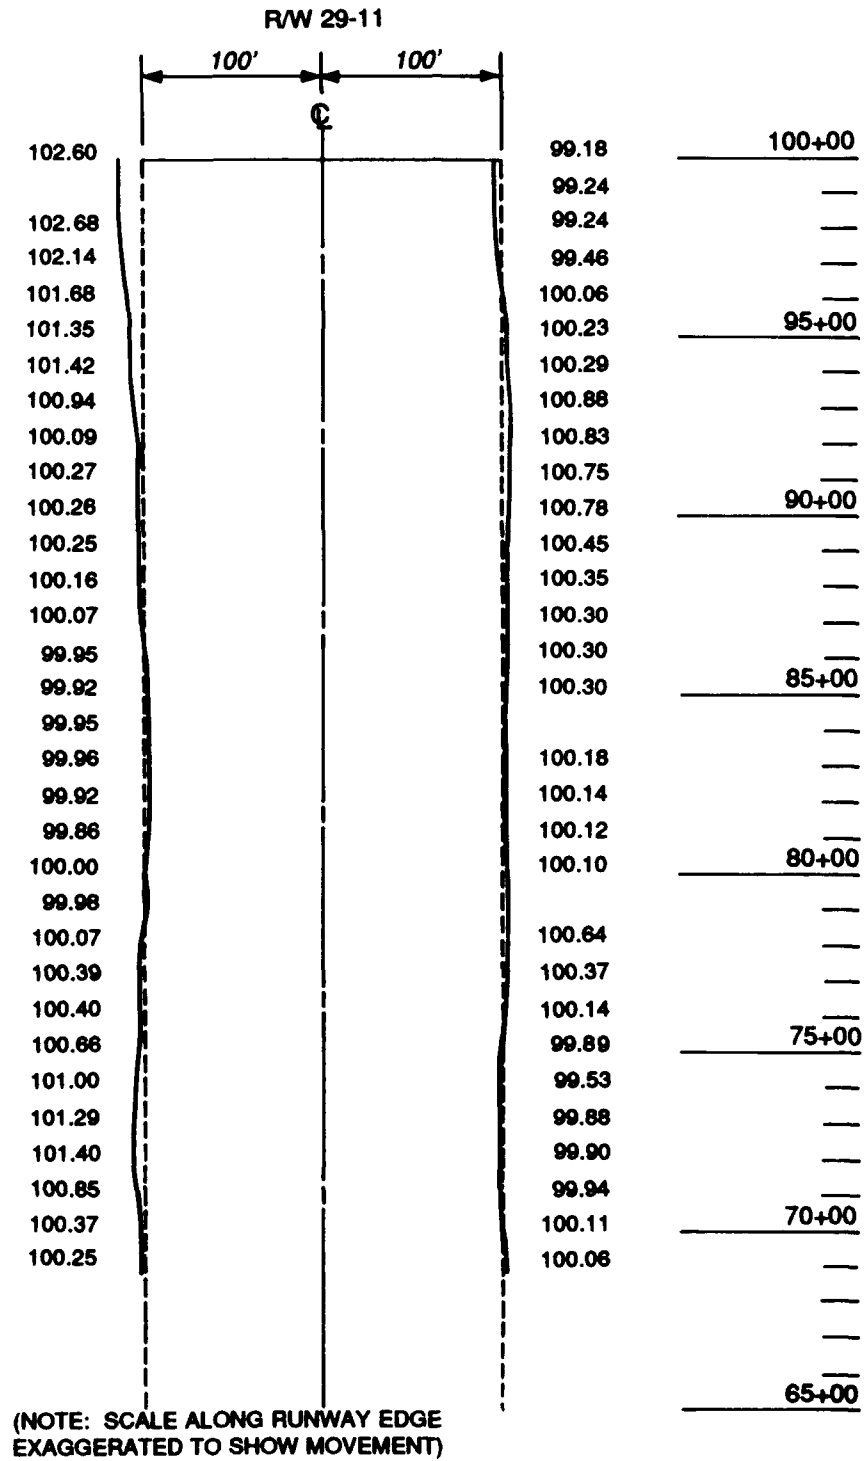
LATERAL SPREADING @ OAKLAND AIRPORT DUE TO LOMA PRIETA EARTHQUAKE

Figure 6. Lateral spreading of runway

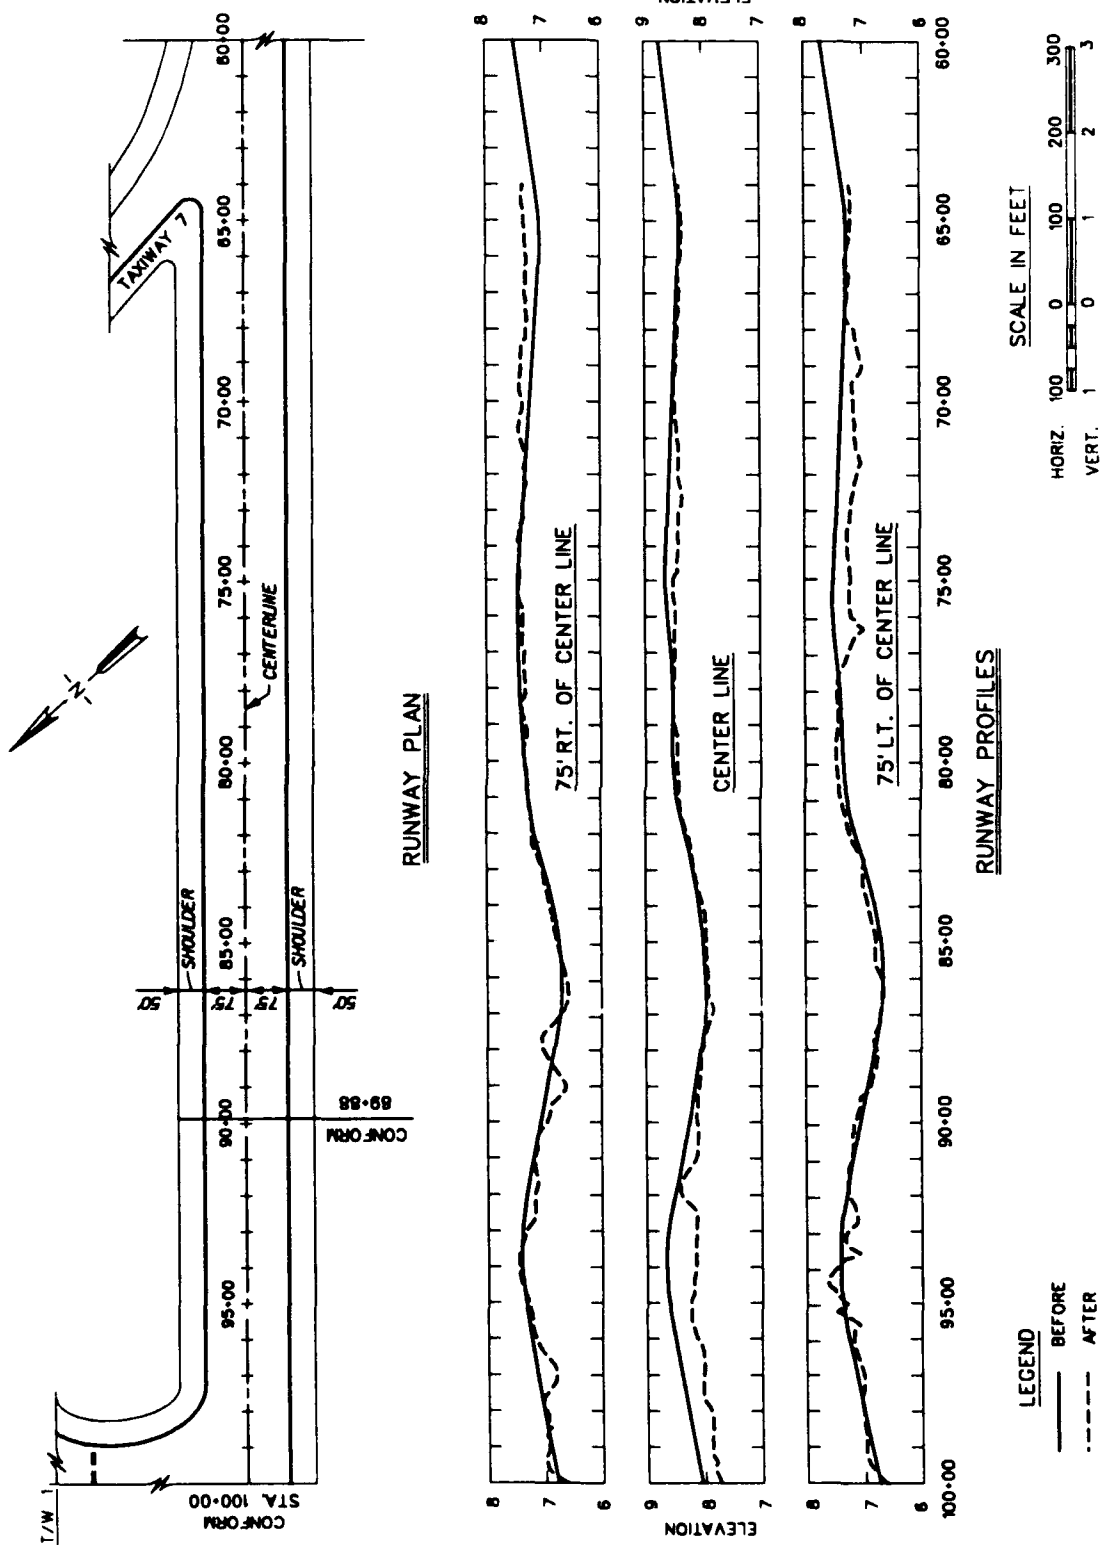
Figure 7. Runway profiles

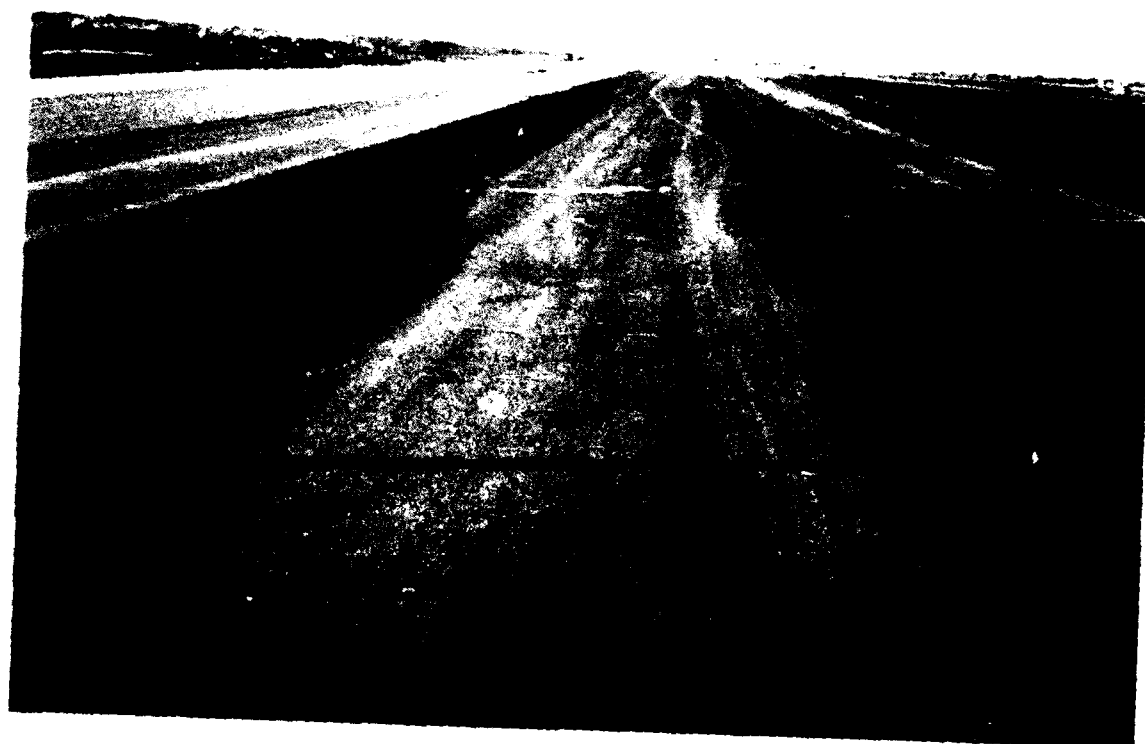
23. The majority of the cracks that formed in the pavement as a result of the earthquake followed joints in the pavement and then skewed off at various angles until they met another joint which they would then follow. Figures 8 and 9 show where the cracks followed construction joints in the AC pavement. Figure 10 shows a transverse crack, which did not follow a joint. Figure 11 shows a longitudinal crack; one side of the crack dropped in elevation significantly greater (8 in.) than the adjacent side of the crack. It should be noted that the 8-in.-thick, 15-year old AC pavement, showing signs of embrittlement, deformed 8 in. over a span of 11.2 ft without visible surface cracking at the location shown in Figure 11. Sand boils formed at many cracks. Figures 12 and 13 show sand boils that formed.

Figure 9. Close-up of crack following construction joint

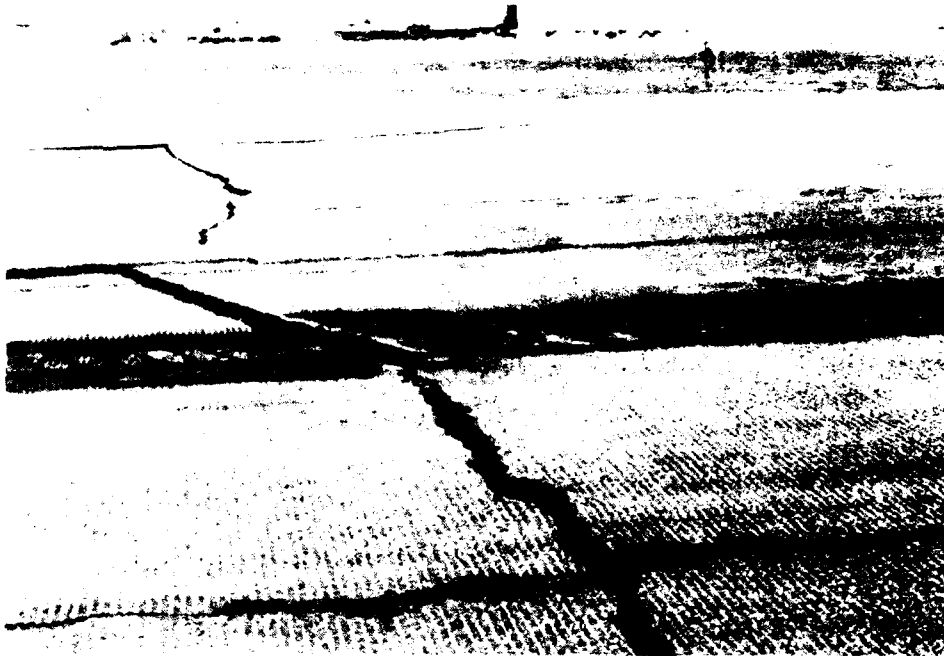
Figure 10. Transverse crack not following construction joint

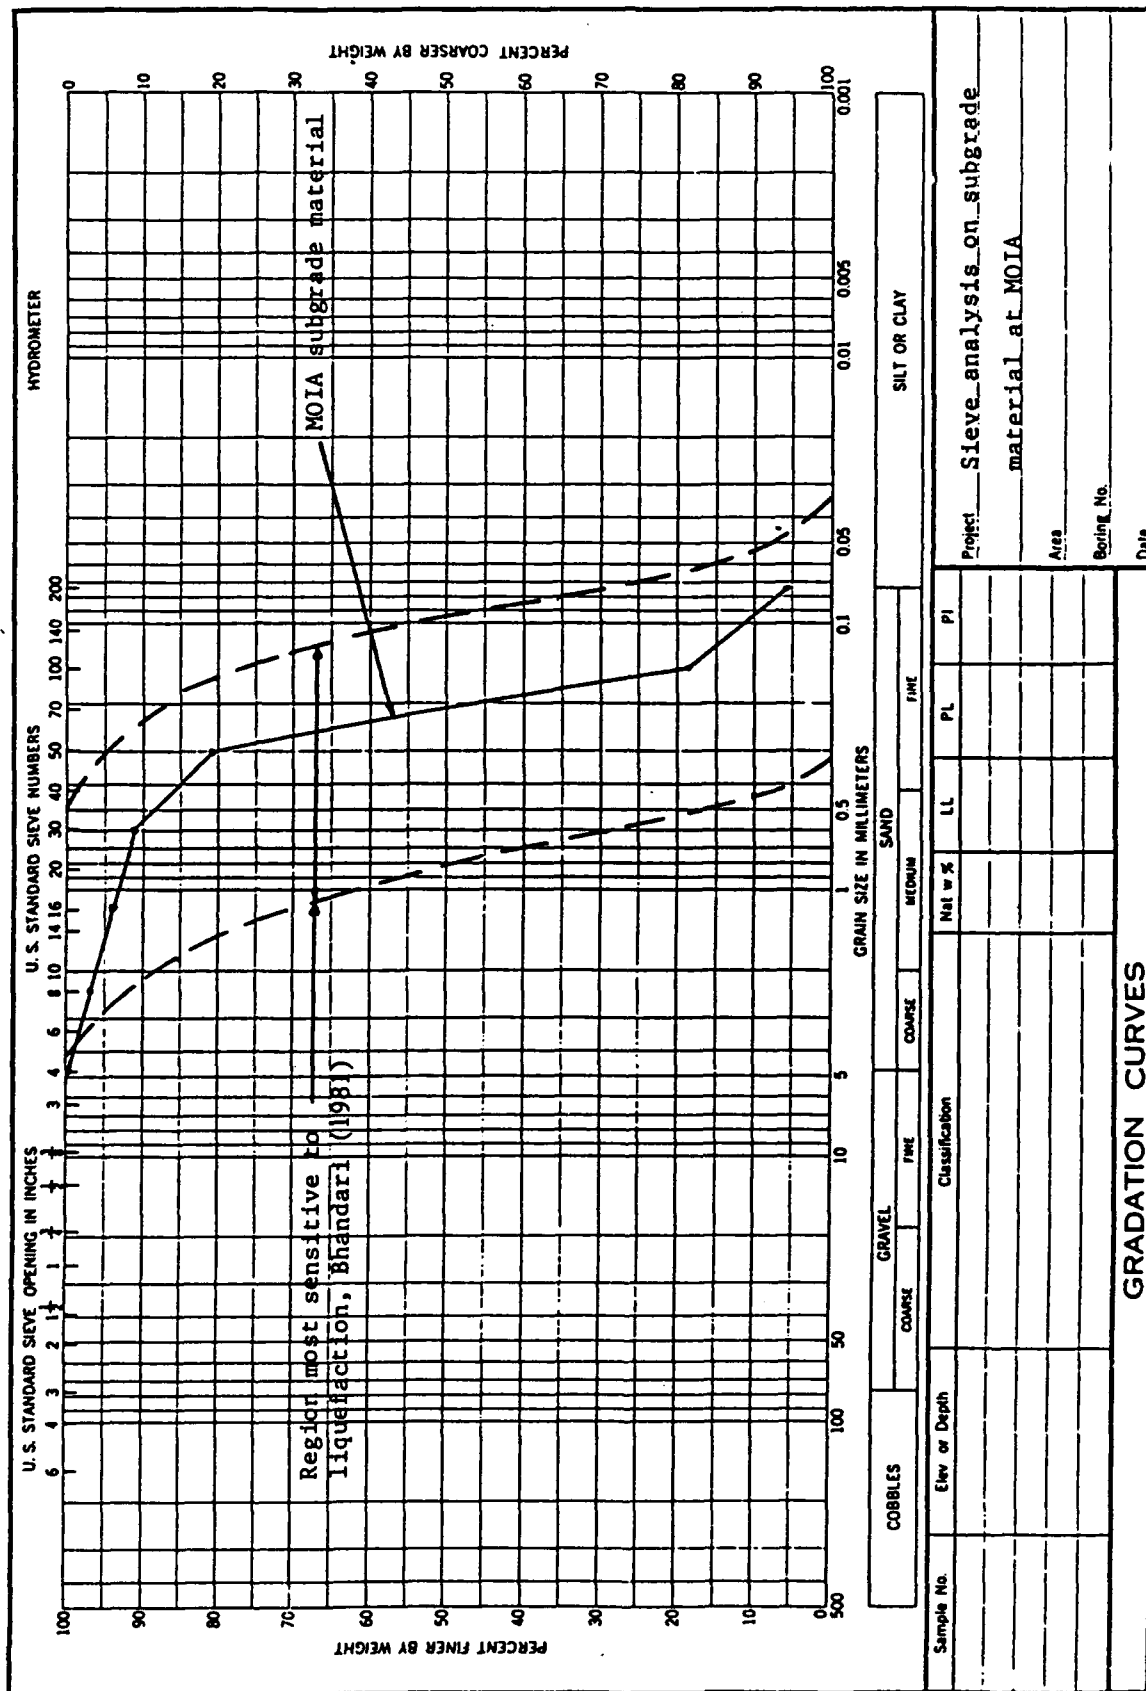
Figure 15. Sieve analysis results on sandfill

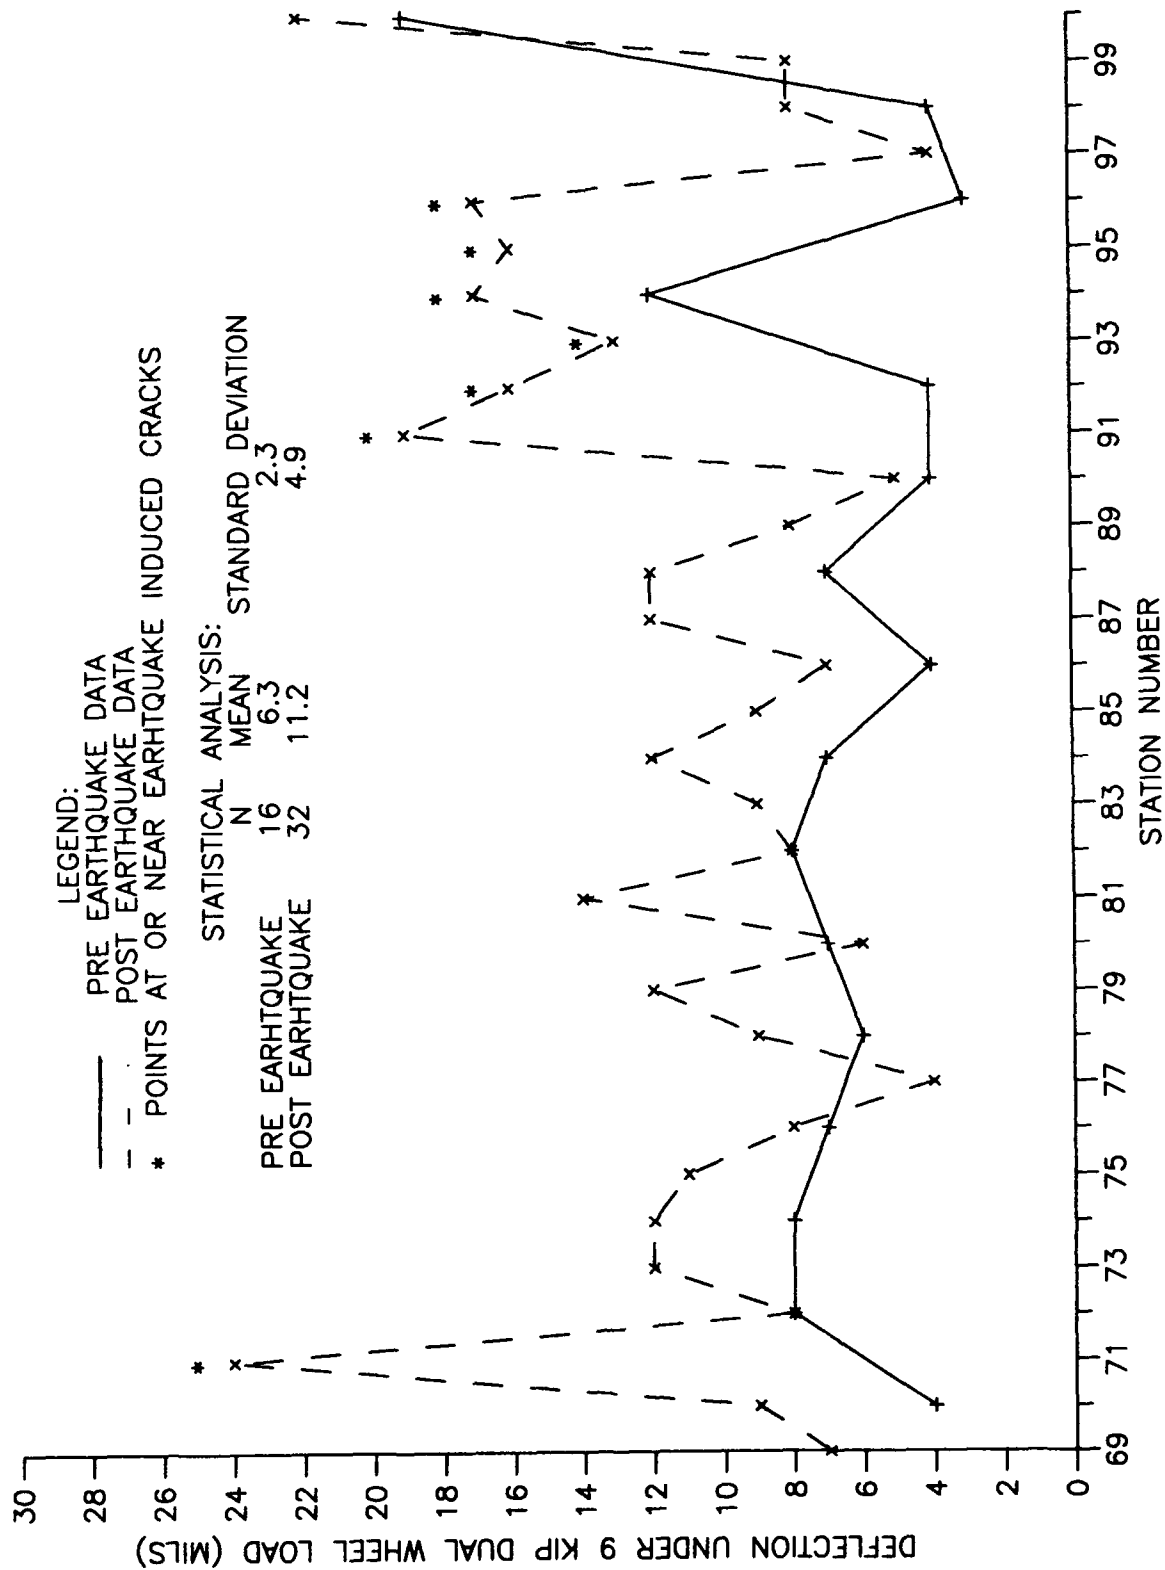
35. Following the visual ground survey, ground and aerial photos were taken to record the damage that occurred as a result of the earthquake. A topographic survey of the damaged area was run on a 25-ft grid to determine the extent of grade changes. Deflection data were taken with the Benkelman Beam to compare to data that were taken 3 years previously (1986). Results of the Benkelman Beam tests showed that the deflections were not significantly different than those from the 1986 results except for measurements directly adjacent to the cracks where the deflections were substantially larger. Figure 16 compares the deflection measurements before and after the earthquake and illustrates the increase in deflections immediately adjacent to the earthquake-induced cracks.

Figure 16. Benkelman beam deflection data

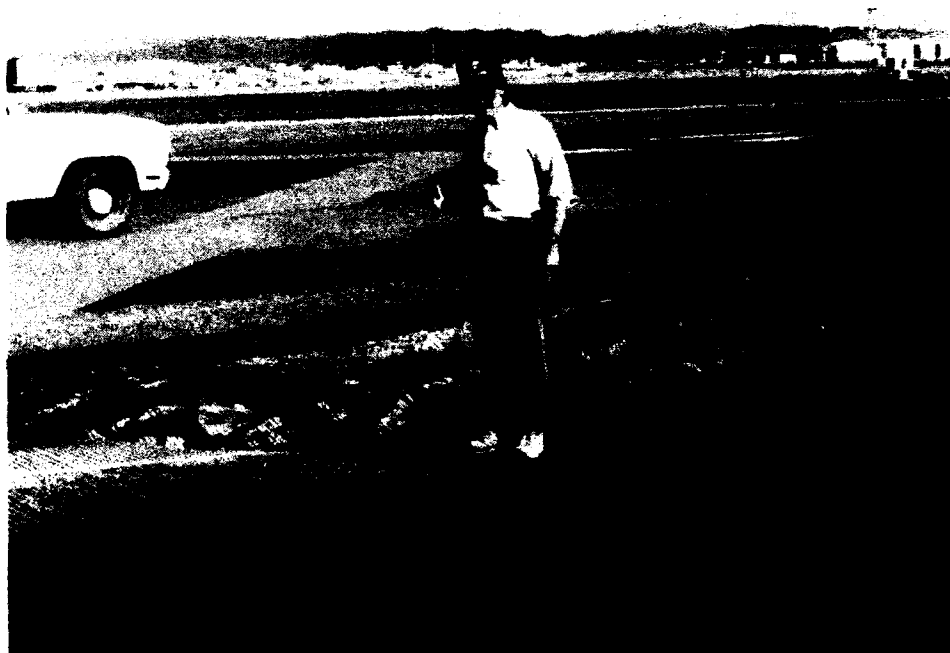
formed at the time of the earthquake. Figure 21 illustrates a typical area of broken pavement adjacent to an earthquake crack produced by proof rolling.

Figure 21. Pavement broken by proof roller adjacent to crack
